EXHIBIT 76

Forced air **warming** device failure resulting in smoke and soot on a surgical patient [A-732-0069-00191]

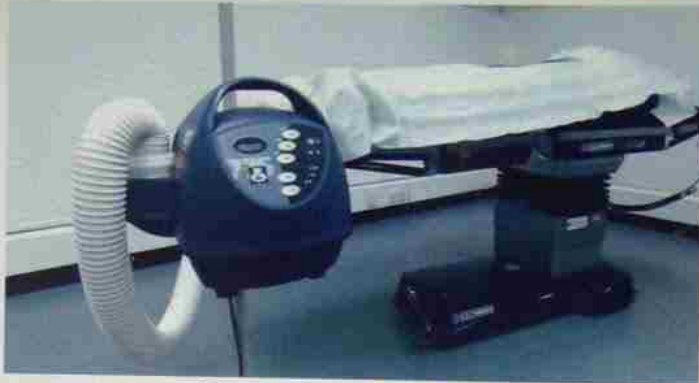
Figure 1: Forced air **warming** unit attached via hose to disposable blanket

Forced air **warming** (FAW) devices are used in the operating room to maintain normothermia. Proper use involves connecting the hose of the **warming** unit to a disposable blanket with a perforation pattern that evenly distributes heat across the patient's body (Fig 1). We present the case of a FAW device that malfunctioned after it became wet, depositing black soot on the patient.

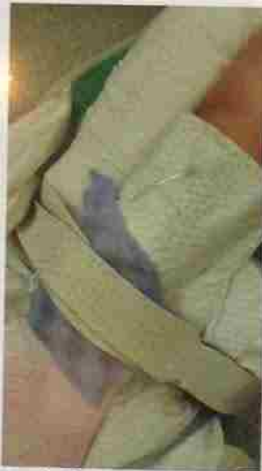
Figure 2: Soot marks on sheets, SCDs and patient lower extremities

A 67 year old patient with lung cancer presented for robotic-assisted left upper lobectomy. The patient was taken to the operating room, ASA monitors were applied, general anesthesia was induced, and the airway was secured. After arterial and peripheral line placement, the patient was positioned in the right lateral decubitus position. A FAW blanket was applied to the patient's lower body, and the heating device was set to 43° C. The Foley temperature was initially 35.7° C, decreased to 35.0° C, and increased to 35.8° C by the end of the case. While closing the chest, the line isolation monitor alarmed and was investigated. A few minutes later smoke was noticed in the field, and the drapes were removed to identify the source. No flames were seen, and no obvious source of smoke was identified. Then, black punctate spots were noted on the sheets and the patient's lower extremities (Fig 2). Upon investigation, the black spots were soot deposited on the patient in the pattern of the perforation holes of the FAW blanket (Fig 3). The soot was wiped off the patient, and there was no injury to the patient. The blanket itself was dry, but the **warming** unit was sitting in irrigation that spilled from the surgical field.

The Food and Drug Administration and Anesthesia Patient Safety Foundation discourage "hosing" (1-2), defined as the misuse of FAW devices by applying the hose directly to the patient or to a non-inflatable blanket. This misuse has resulted in various reports of first to third degree burns (3-5), including a reported amputation due to muscle necrosis. In our case, however, the FAW device was properly utilized with the hose attached to an inflatable blanket. Our biomedical service evaluated this incident and device and concluded that the air-intake on the bottom of the unit entrained irrigation into the device, causing a short circuit within the unit. This electrical short created smoke inside the device, which was then blown out through the hose and deposited as soot through the perforation holes in the blanket. The unit was removed from service and returned to the manufacturer. This is a case of a near-miss that could easily have resulted in an OR fire.

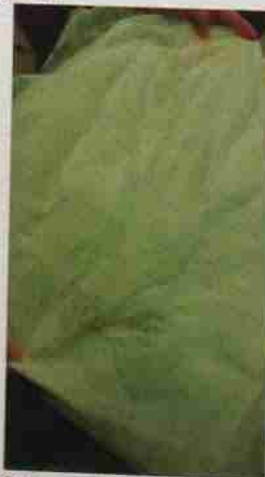
Figure 3: Perforation holes of disposable blanket with black soot
